TECHNICAL INFORMATION

ENGINE WATER PUMP

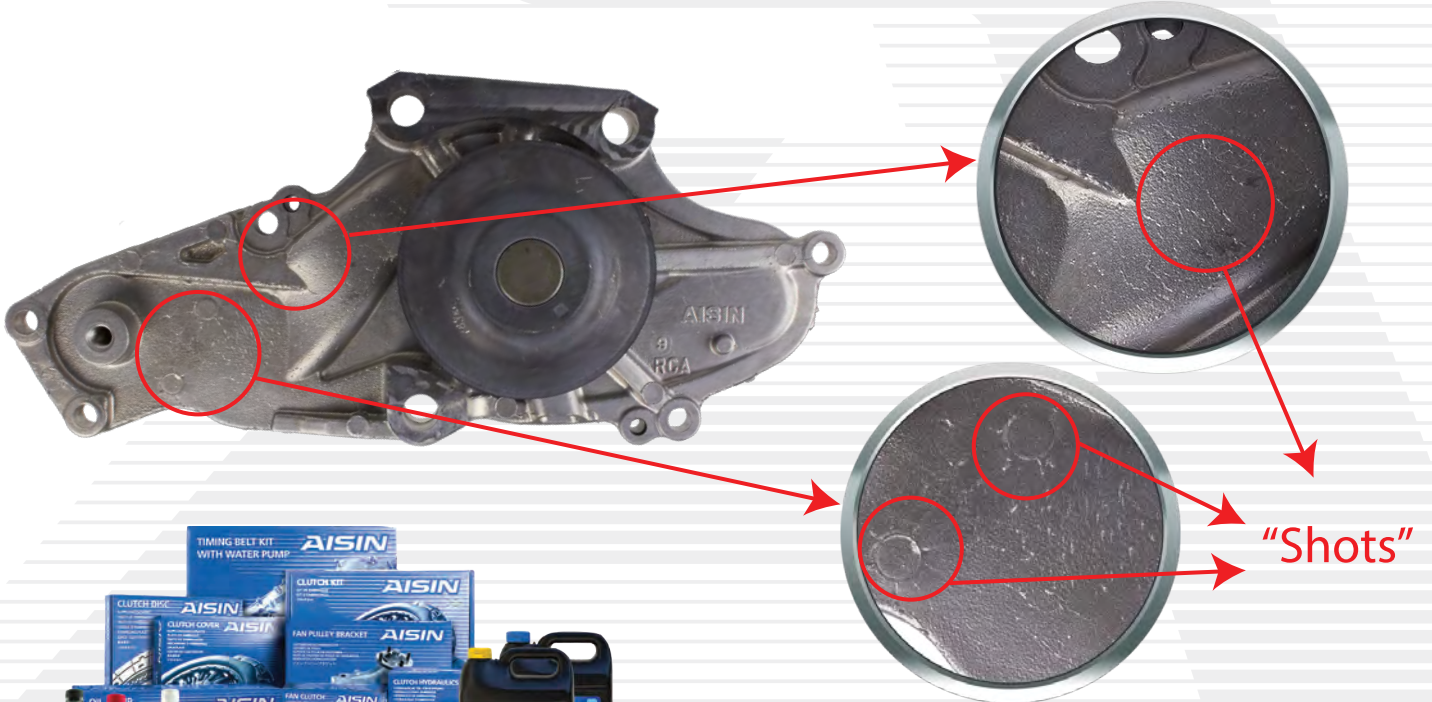
We want to answer a few concerns we've received, regarding the appearance of "Fractures" on the aluminum casting of our **WPH-801** water pump, which is commonly referred by manufacturing engineers as "**Shot**". Shot is defined as: Tiny heat checks from tooling.

Heat checks develop due to many temperature cycles on a tooling mold, they are perfectly **NORMAL**, and do not present a structural or performance issue related to the part. (see photos below)
