# TECHNICAL INFORMATION

## ENGINE WATER PUMP

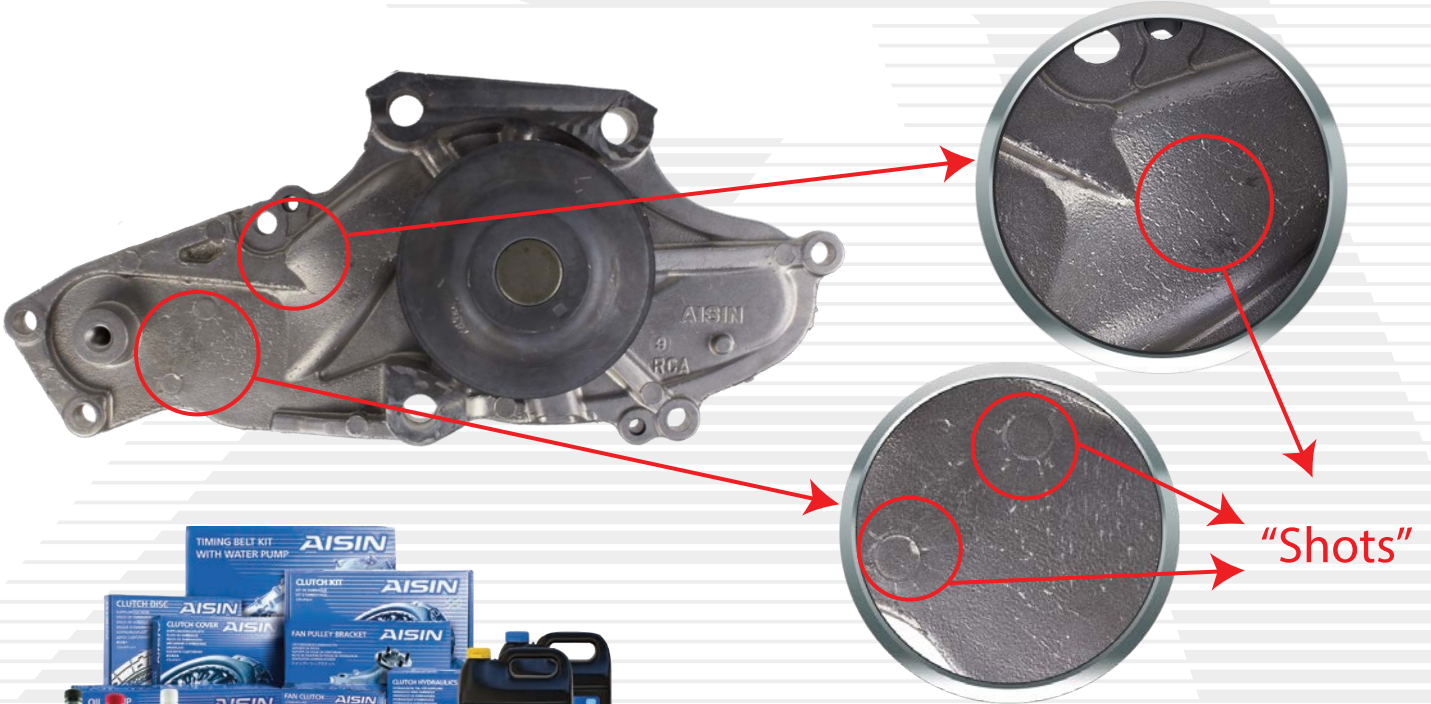
We want to answer a few concerns we've received, regarding the appearance of "Fractures" on the aluminum casting of our **WPH-801** water pump, which is commonly referred by manufacturing engineers as "**Shot**". Shot is defined as: Tiny heat checks from tooling.

Heat checks develop due to many temperature cycles on a tooling mold, they are perfectly **NORMAL**, and do not present a structural or performance issue related to the part. (see photos below)
