## Troubleshooting: Protruding Edge on Brake Rotor Surface

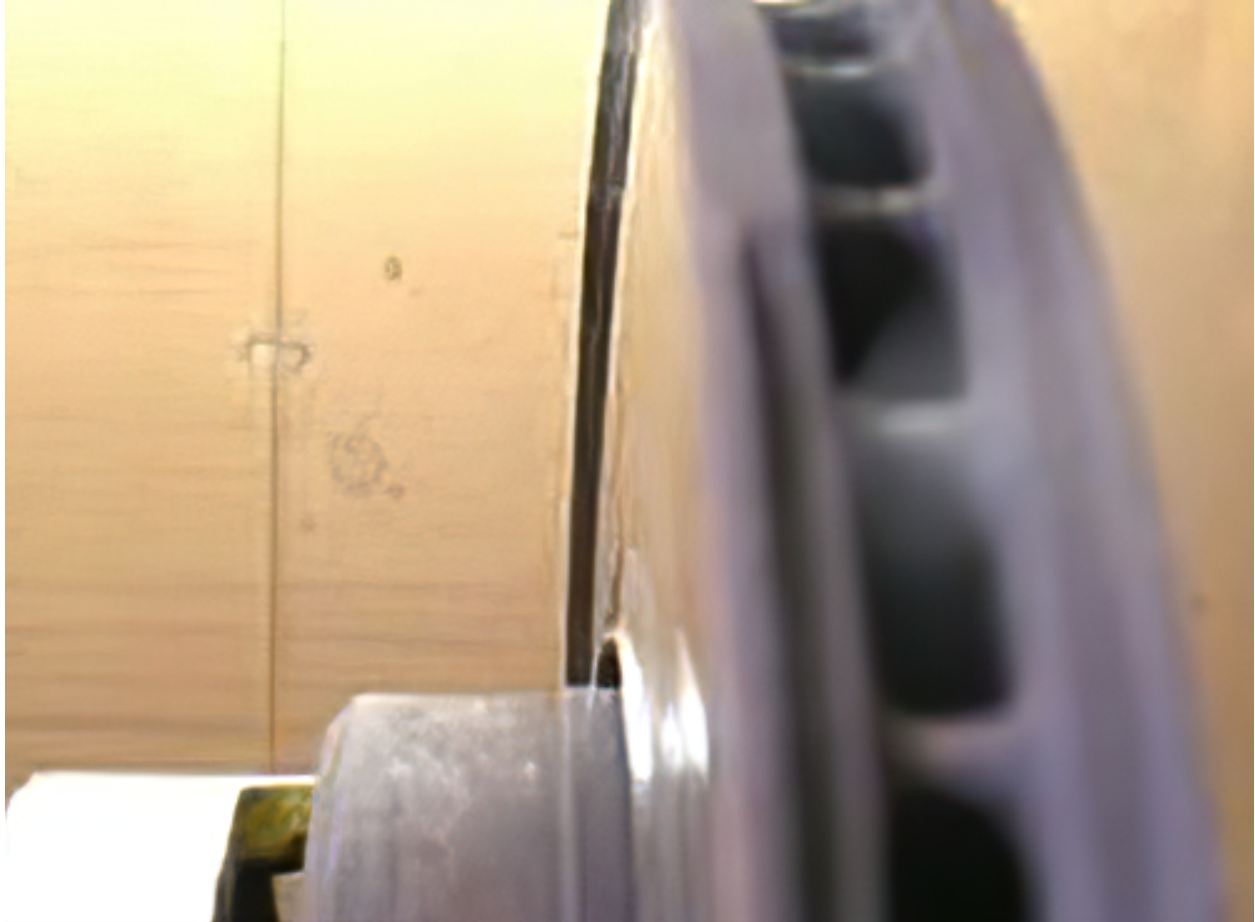
Protruding edge on brake rotor surface

- Brake rotor shims are not installed
- Brake pad backing plate got in contact with rotor surface due to pad wear
- Rotor is worn out

- Check if brake rotor shims are installed
- Check the pad wear
- Check the rotor wear
- Replace the rotor
