## 1 Weep Hole Coolant Leak

## 2 Seepage

## 3 Overheating

## 4 Abnormal Noises

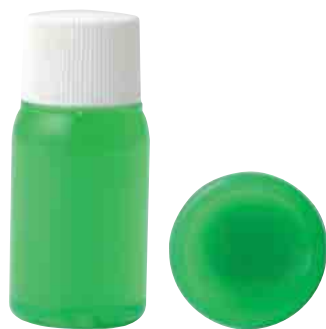
### ① Coolant degradation

New

- Always flush the radiator and replace with new coolant.
- Replace coolant regularly.

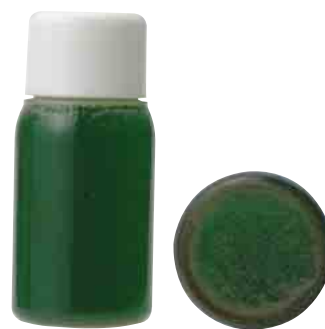
38,000 km (23,000 miles) 4 years old

Older coolants have higher risks of leakage.

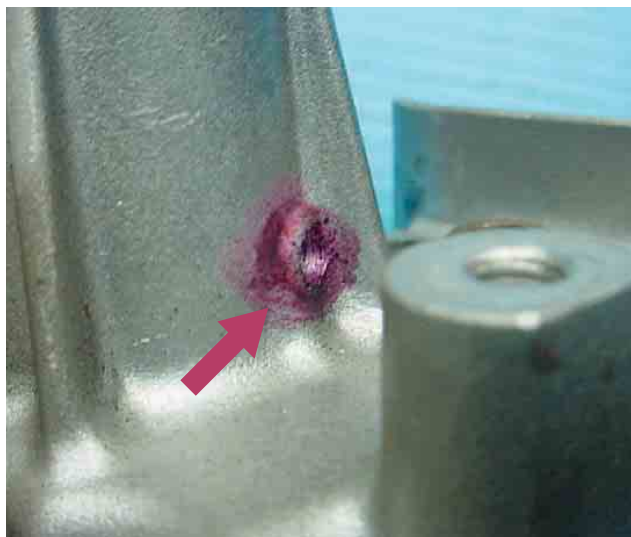
## ② Fair and Poor, leak from the weep hole

**Normal** Dried coolant residue.

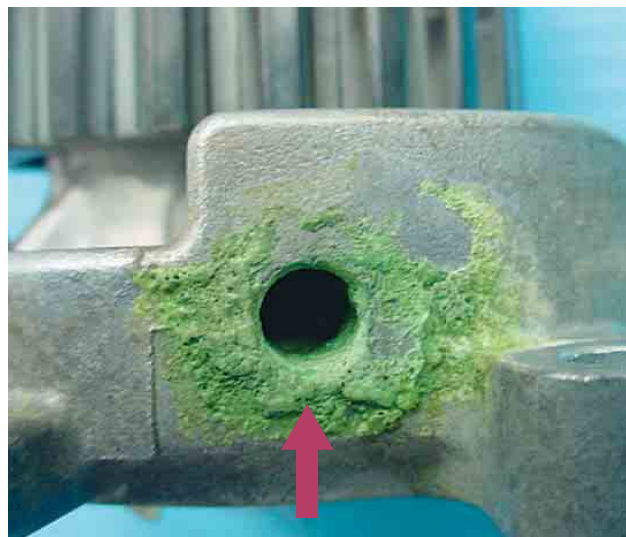
- Contamination and sludge has damaged the mechanical seal, reducing sealing performance.

**Damaged** Large coolant bleed mark, dampness or dripping.

- Before installing the new water pump, flush the cooling system 2 - 3 times and let engine idle for about 3 minutes with the old pump to remove any sludge deposit.
- Replace the anti-freeze regularly at the specified mixture and fluid level.
- Do not use sealants (RTV) when gaskets are supplied.
- When sealants are necessary, apply evenly and do not allow excess to enter the water channel.

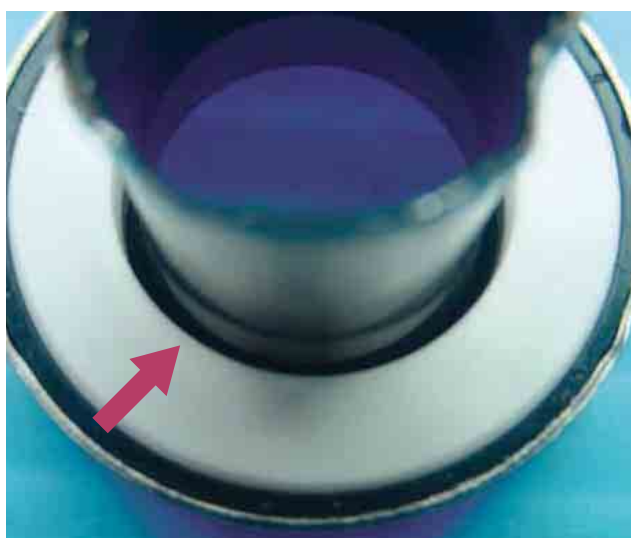
## ③ Fair and Poor, mechanical seal ceramic

**Normal** Clean ceramic.

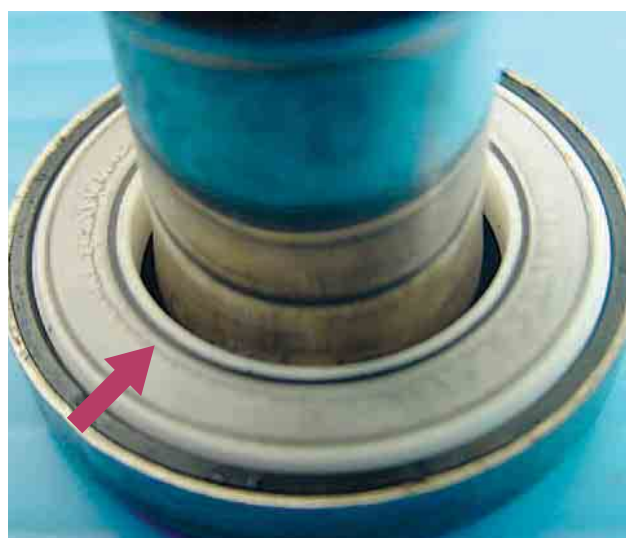
**Damaged** Accumulated sludge (Contaminated coolant).

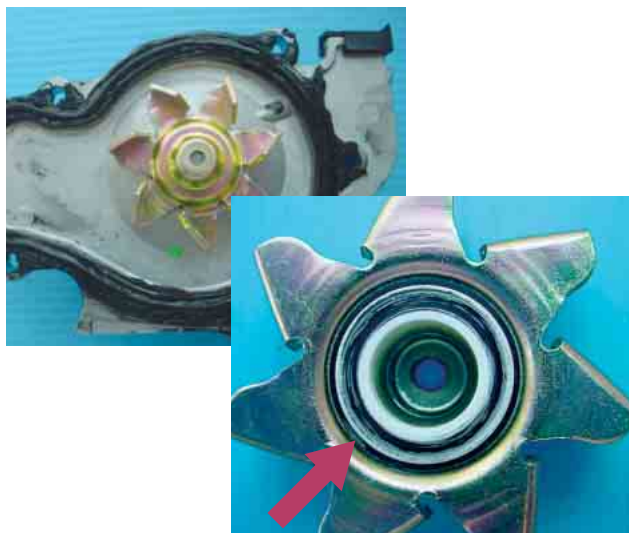
① Poor application of sealant

Sealant has interfered with the mechanical seal causing leaks.

- Use manufacturer specified sealant
- Do not use sealants when gaskets are supplied
- Do not use adhesives in place of sealants or gaskets
- Install the new water pump in a diagonal (star) pattern and apply torque specified by the vehicle manufacturer
- Clean mounting surface free of contaminants
- Do not re-use old gaskets and previously applied sealant

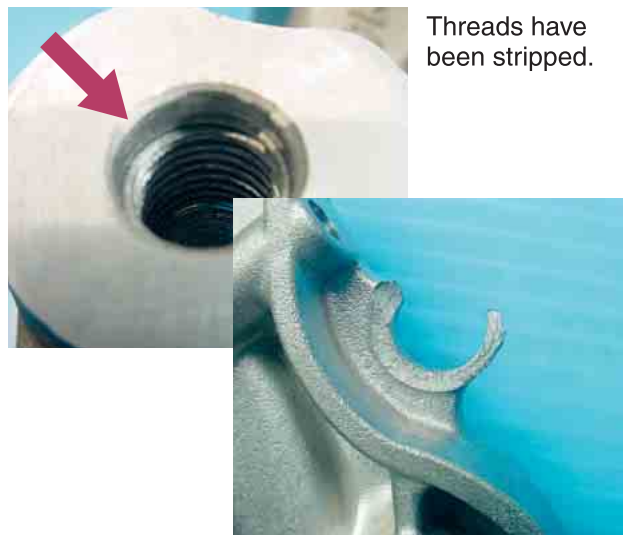
② Excess torque of the mounting bolt

Threads have been stripped.

Unevenly tightened or over torqued.

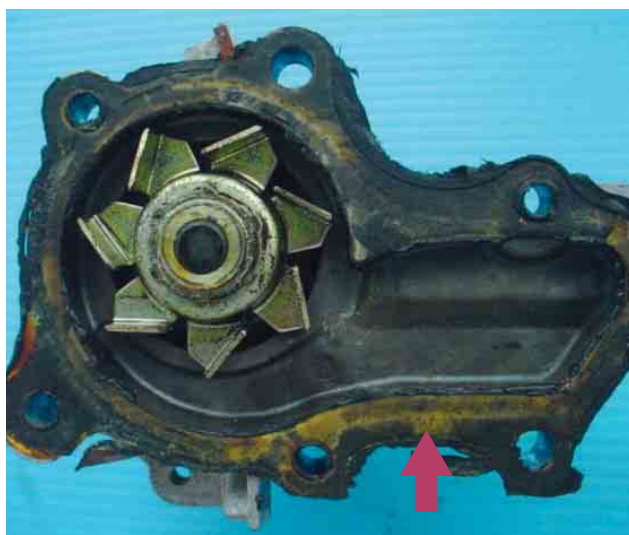
③ Poor cleaning of the mounting surface

Insufficient accuracy on the mounting surface.

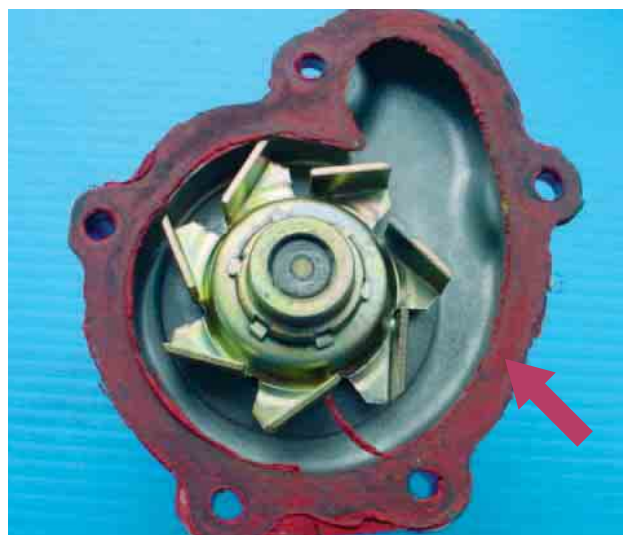
④ Sealant used on supplied gasket

Gasket performance has degraded.

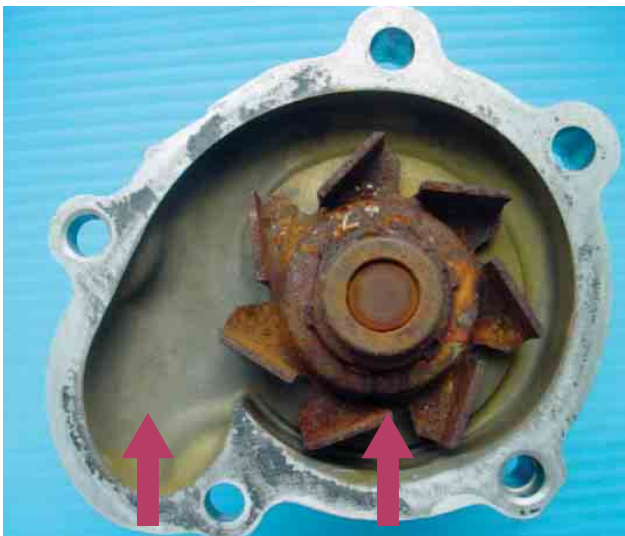
### ① Coolant degradation

- Old/used coolant
- Coolant deterioration
- Insufficient flushing of the radiator

Contamination of water pump body      Impeller corrosion

- Discontinue use of old coolant
- Fully flush the radiator
- Replace coolant with manufacturer's specified mixture and fluid level

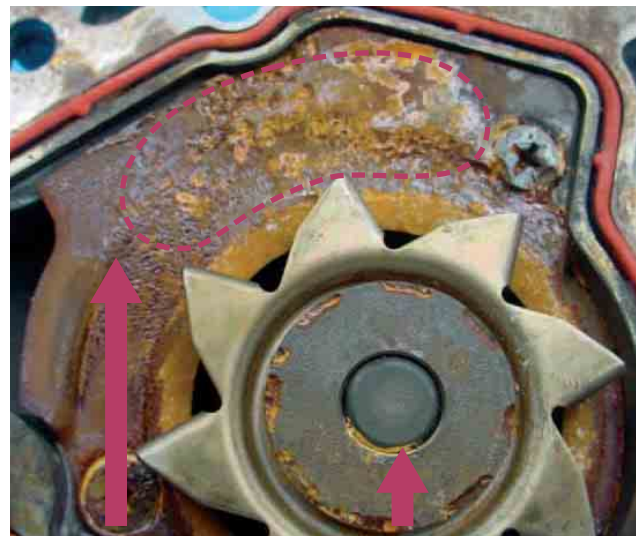
### ② Cavitation

Cavitation      Corrosion around crimp

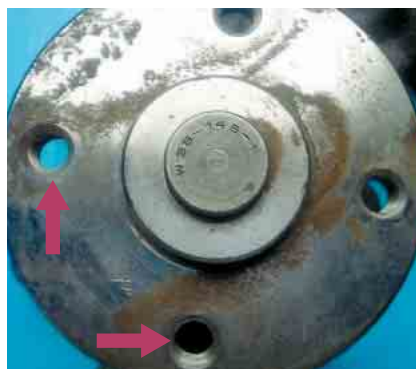
Damage at the stud bolt ends

- Tighten belt tension to vehicle manufacturer specifications
- If the fan coupling pulley is reused, confirm the run-out with a dial indicator
- Replace fan coupling pulley with new on older vehicles or high mileage engines
- Confirm that the bearing is lubed and free of rust, and replace if necessary

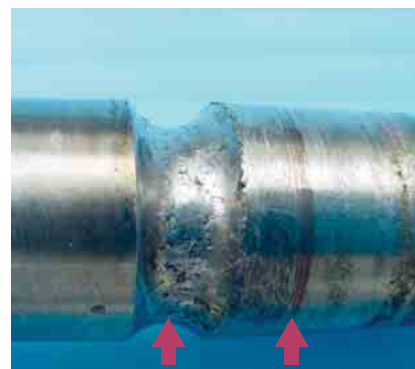
### ② Flecking at the bearing

Damage due to  
overload and seepage

Damage due to  
excess backlash

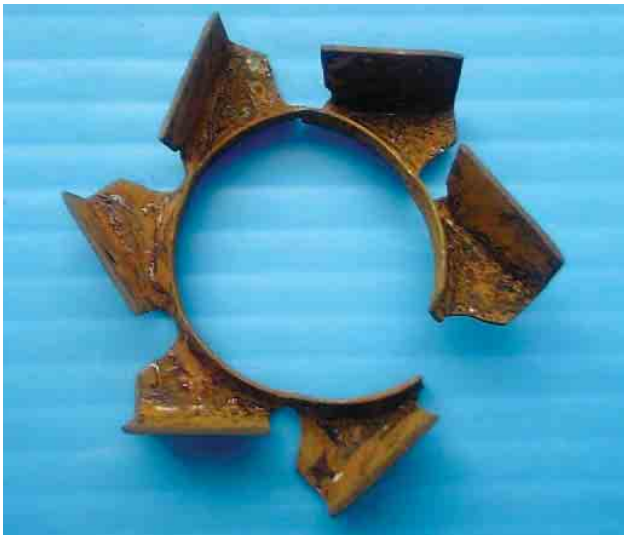
### ① Severely corroded impeller

When replacing the water pump, flush the coolant system 2 to 3 times to wash out sludge, scale and rust deposits. Replace coolant to the manufacturer's specified mixture and fluid level. Re-using or using degraded coolant will corrode the body, impeller, and mechanical seals.

- Fully flush the radiator
- Replace with new coolant when changing the water pump
- Use correct coolant mixture
- Fill system to the correct fluid level
- Bleed cooling system of air

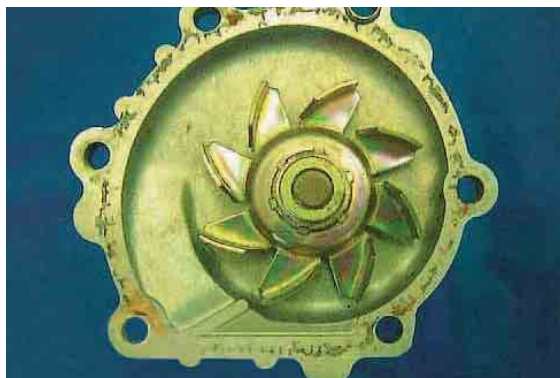
No corrosion can be seen on the impeller when the coolant is clean.

Mileage: 48,000 km (30,000 miles)  
Period: Approximately 1.6 years  
Total mileage: 149,000 km (92,500 miles)

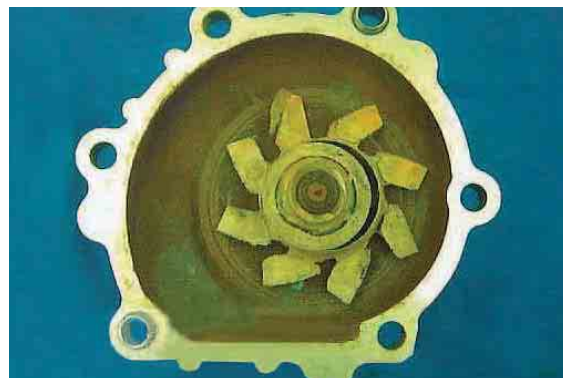
Corrosion can be seen on the impeller when the coolant is degraded (contaminated / deteriorated).

Mileage: 7,500 km (4,700 miles)  
Period: Approximately 1 year  
Total mileage: 105,000 km (65,000 miles)

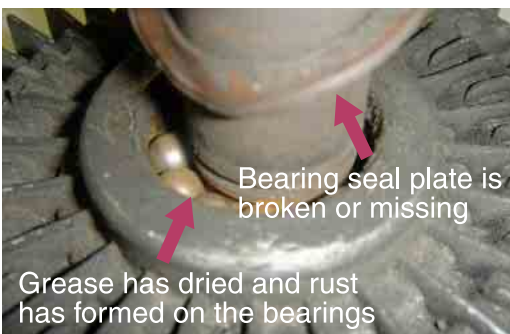
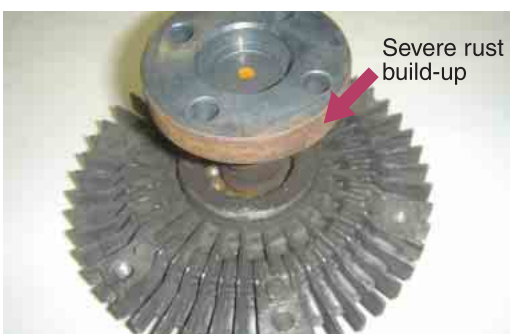
### ① Enlarged view of a fan coupling

- **Damaged fan coupling was reused**
- Fan coupling was not installed correctly (off-centered)

If usage is continued

- Install new fan coupling when replacing water pump
- If fan coupling is reused, ensure that:
  - there is no binding or play in the bearing
  - the components are free of rust and debris
  - check for run-out with a dial indicator

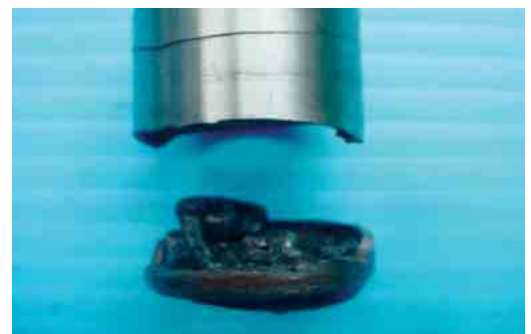
### ② Fractured bearing

- Fracture of the water pump body
- Fracture of the water pump bearing
