Troubleshooting: Brake Pad Backing Plate Rust

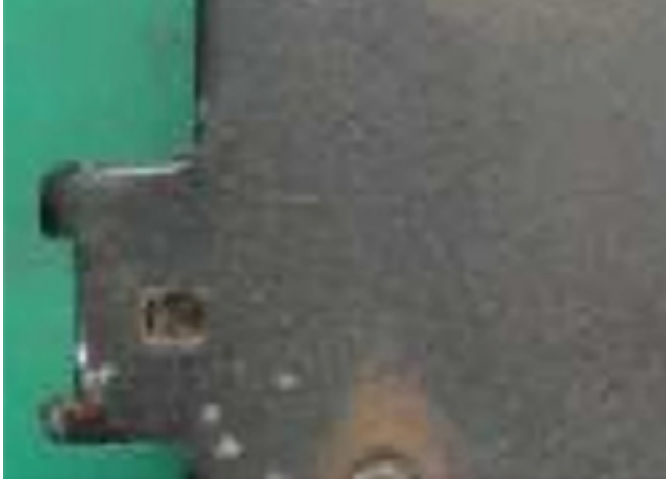
Brake pad backing plate is rusted

- Backing plate coating was affected by high humidity or corrosive chemicals

- Check if backing plate rust has affected pistons or other caliper parts
- Replace the corroded pads with pads featuring a better rustproofing
- Replace the caliper parts affected by rust
